**Car Inspection Report**

### **Hyundai Verna**

SX1.5VTVT IVT | 2020 | AT | Petrol

Report generated on: 24 Apr, 2024

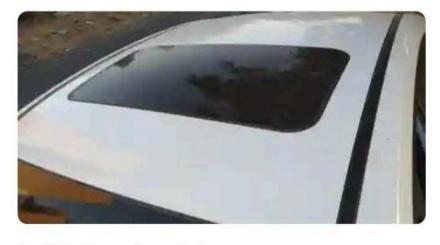
Roof: No Dents, Scratched

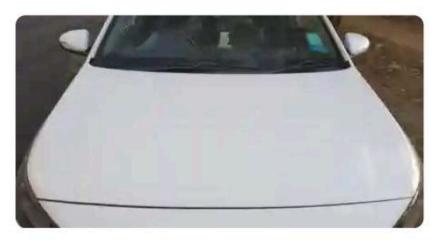
Bonnet/Hood: No Dents, Scratched

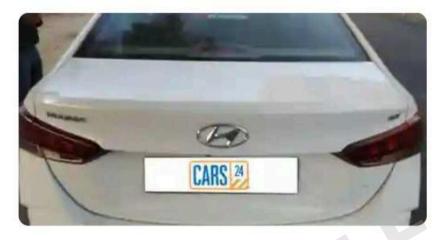
Dicky Door / Boot Door: No Dents, Scratched

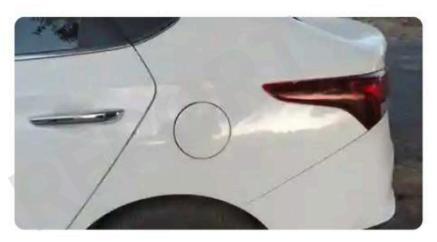
Quarter Panel LHS: No Dents, Repainted

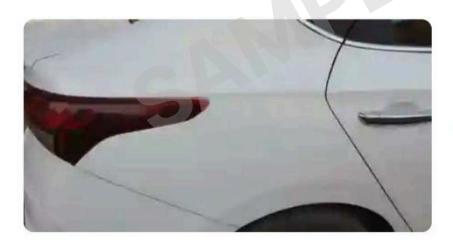
Quarter Panel RHS: No Dents, Repainted

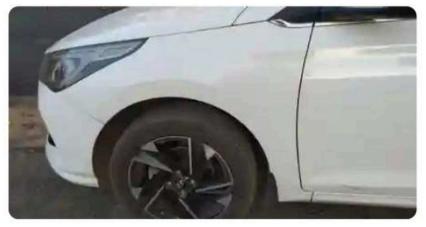
Fender LHS: No Dents, Scratched, Repainted

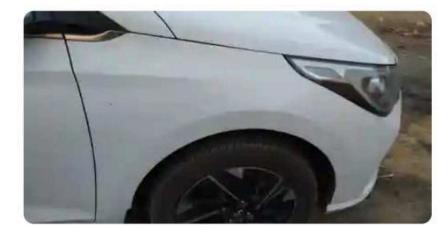
Fender RHS: No Dents, Repainted

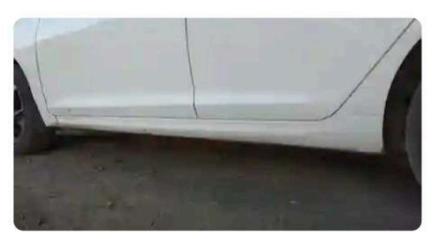
Running Border LHS: No Dents, Scratched, Repainted

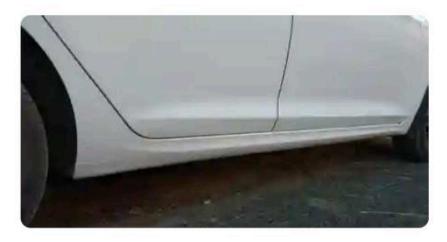
Running Border RHS: No Dents, Repainted

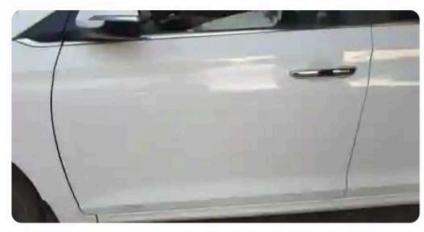
Door LHS Front: No Dents, Scratched, Repainted

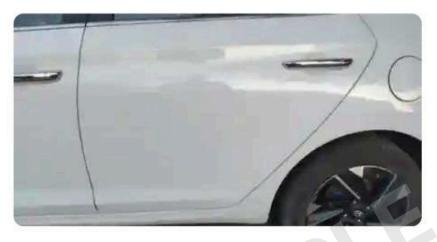
Door LHS Rear: No Dents, Repainted, Scratched

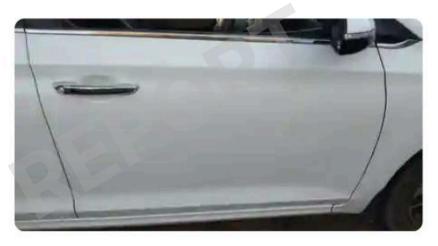
Door RHS Front: No Dents, Repainted

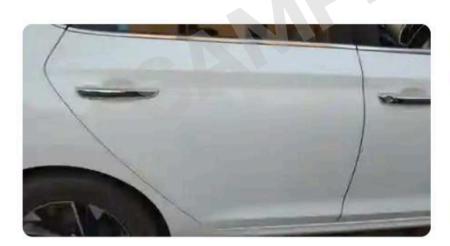
Door RHS Rear: No Dents, Repainted

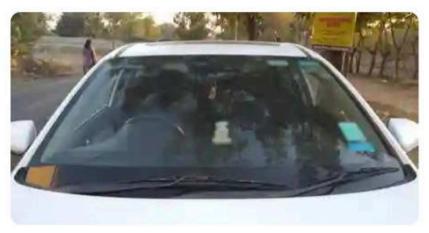
Windshield Front: Scratched

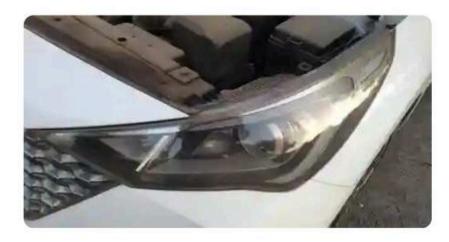
Light LHS Headlight: Scratched

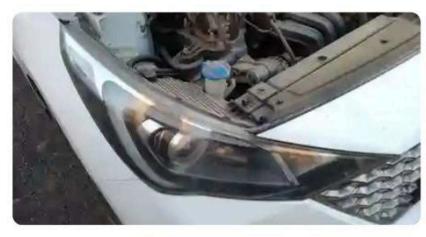
Light RHS Headlight: Scratched

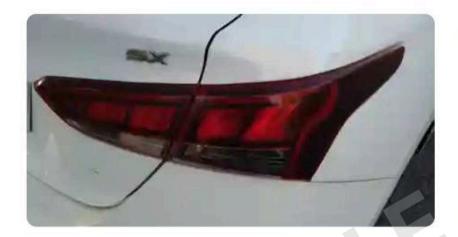
Light RHS Taillight: Scratched

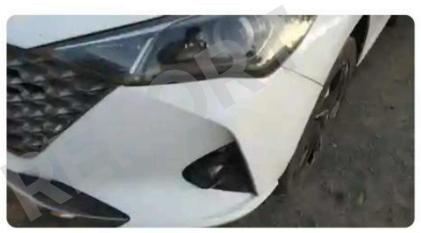
Bumper Front: Scratched, Dented

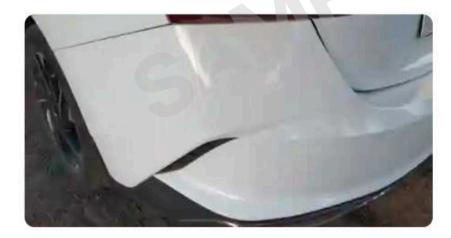
Bumper Rear: Repainted

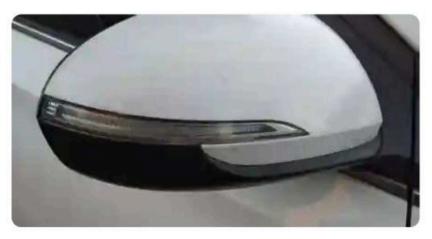
ORVM - Manual / Electrical RHS: Damaged

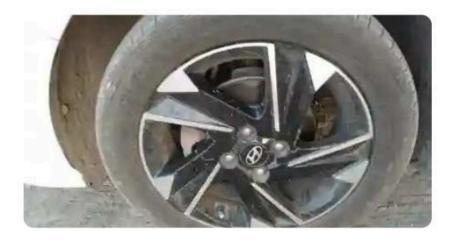
Alloy Wheel: Scratched

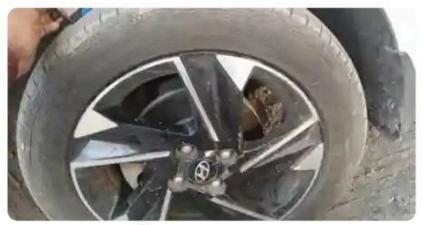
LHS Front Tyre:

70% life remaining

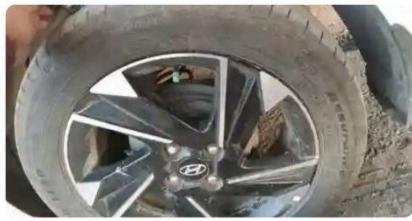
LHS Rear Tyre: 0 30% life remaining

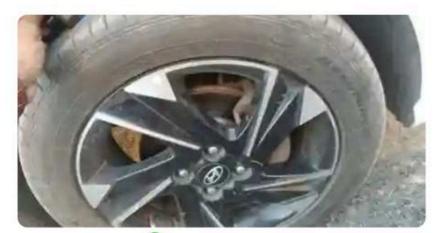
RHS Front Tyre:

70% life remaining

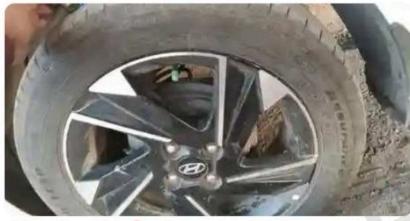
LHS Rear Tyre: 0 30% life remaining
